Manhole Inspection Summary

Manhole # S21GG_051MH

Location Address: **1428 MOUNT ST**

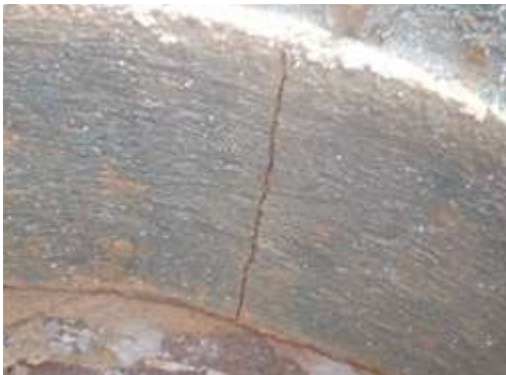
Defect 4

☒ **Cracked**

CRACKED FRAME

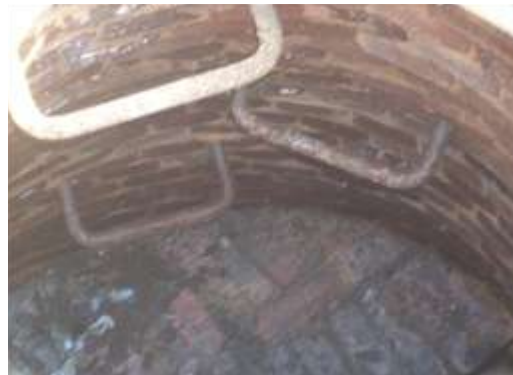
Defect 3

☒ **Corroded**

CORRODED STEPS

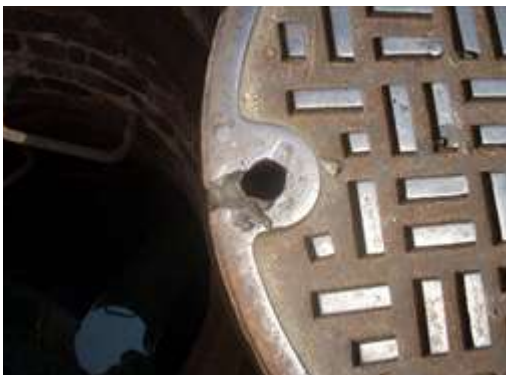
Defect 2

Condition: **Worn**

WORN COVER

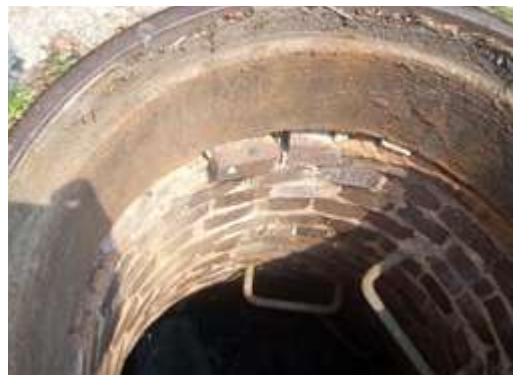
Defect 1

☒ **Loose Brick**

LOOSE CHIMNEY BRICKS

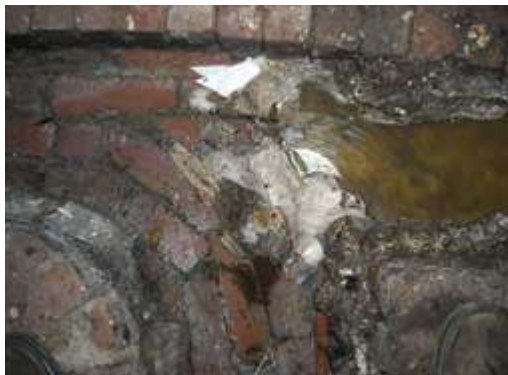
Defect 5

☒ **Debris**

DEBRIS IN CHANNEL

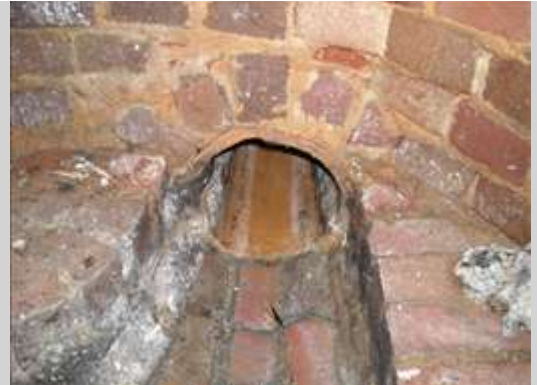
12 O'Clock Outflow

LOOSE CHIMNEY BRICKS

Pipe Height: **8.4** (in.) Rod and Bar (Angled)
Pipe Material: **Clay** ☐ Pipe Lined
Invert Depth: **8.80** (ft.) Flow Characteristics: **Slow**
Deposits: ☐ None ☐ Mud ☐ Sludge ☐ Debris ☒ **Grease**
Silt Depth: **4** (in.) Deposits Extent: **Medium**
Infiltration: **None** Pipe Seal Cond: **Sound**

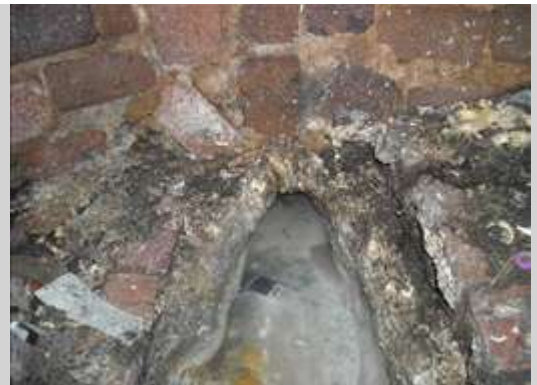
6 O'Clock Inflow

HEAVY DEBRIS - GREASE DEPOSITS

Pipe Height: **6** (in.) Rod and Bar (Angled)
Pipe Material: **Clay** ☐ Pipe Lined
Invert Depth: **8.76** (ft.) Flow Characteristics: **None**
Deposits: ☐ None ☐ Mud ☐ Sludge ☒ **Debris** ☐ **Grease**
Silt Depth: **4** (in.) Deposits Extent: **Medium**
Infiltration: **None** Pipe Seal Cond: **Sound**

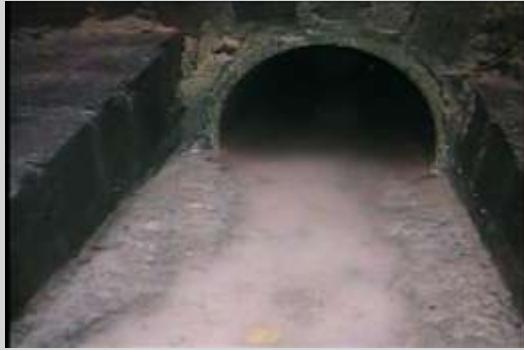
9 O'Clock Inflow

LOOSE CHIMNEY BRICKS

Deposits: ☐ None ☐ Mud ☐ Sludge ☐ Debris ☒ **Grease**

Silt Depth: **4** (in.) Deposits Extent: **Heavy**
